National Dam Inspection Program.
PA-482 Dam (NDI I.D. Number PA-469,
DER I.D. Number 63-72), Ohio River
Basin, Tributary of Harmon Creek,
Washington County, Pennsylvania.
Phase I inspection Report.

May 79

PA-482 DAM
NDI I.D. NO. PA-469
DECEMBER 1, 1978

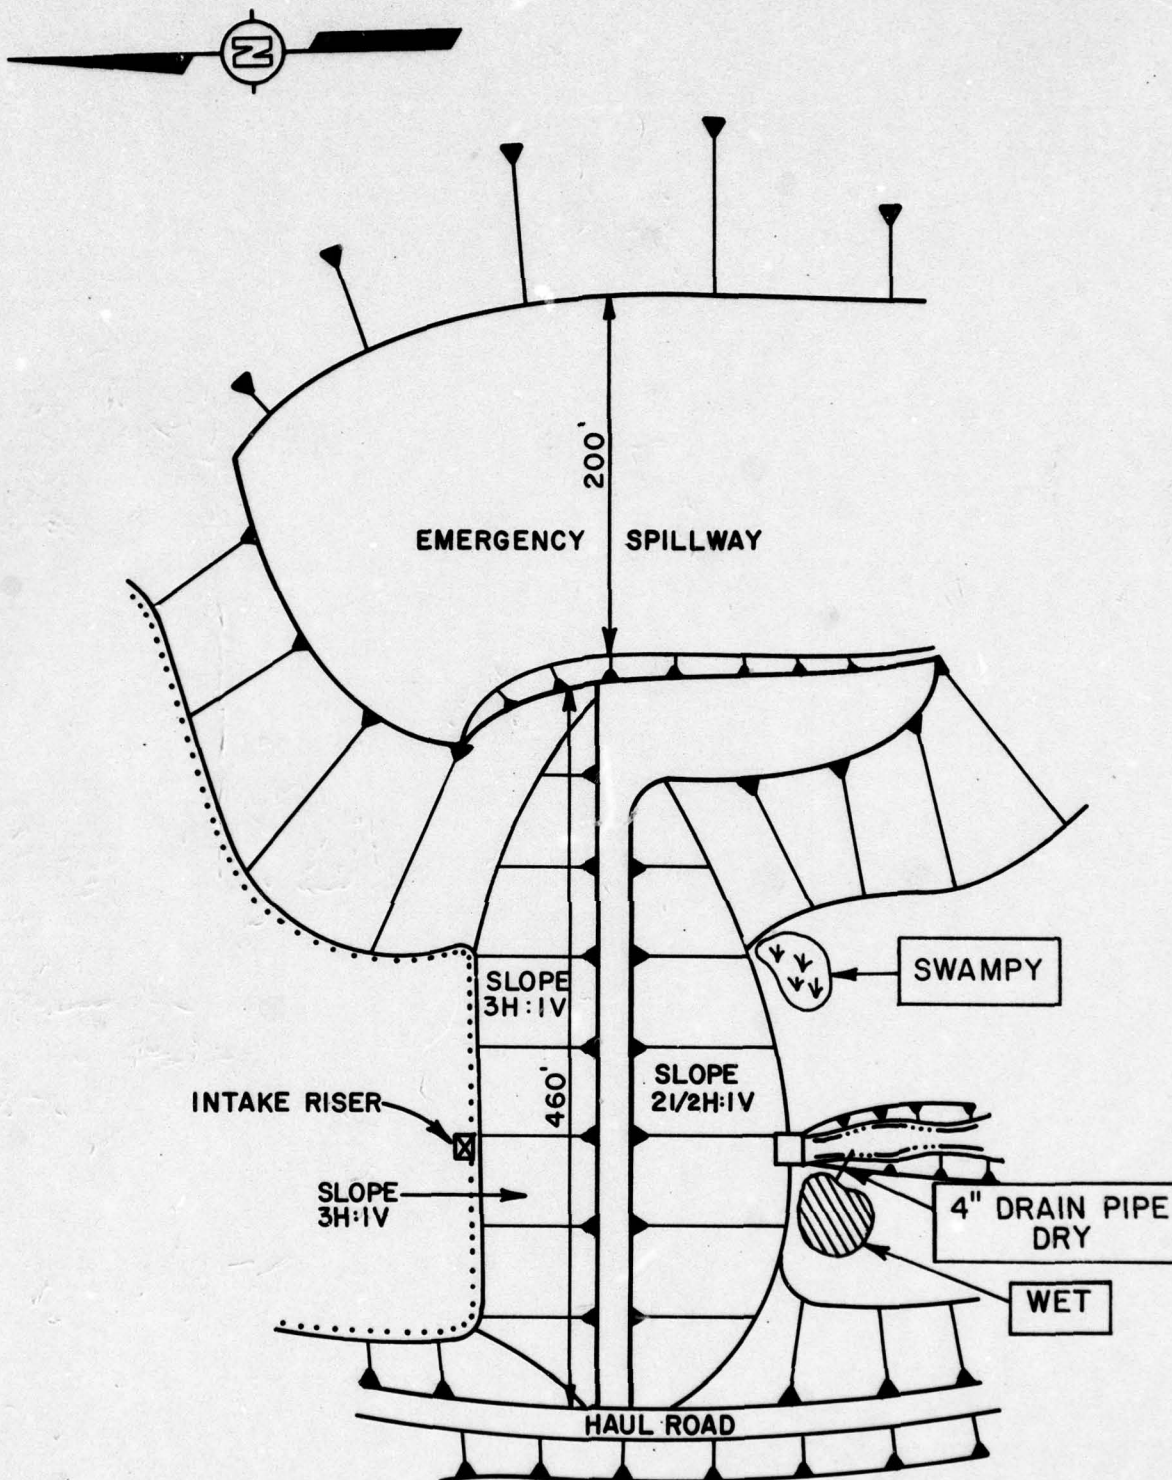
1. EMERGENCY SPILLWAY
FREEBOARD: 5.1 FT.
2. POOL LEVEL DATE OF
INSPECTION: 22 FT. BELOW
CREST OF DAM

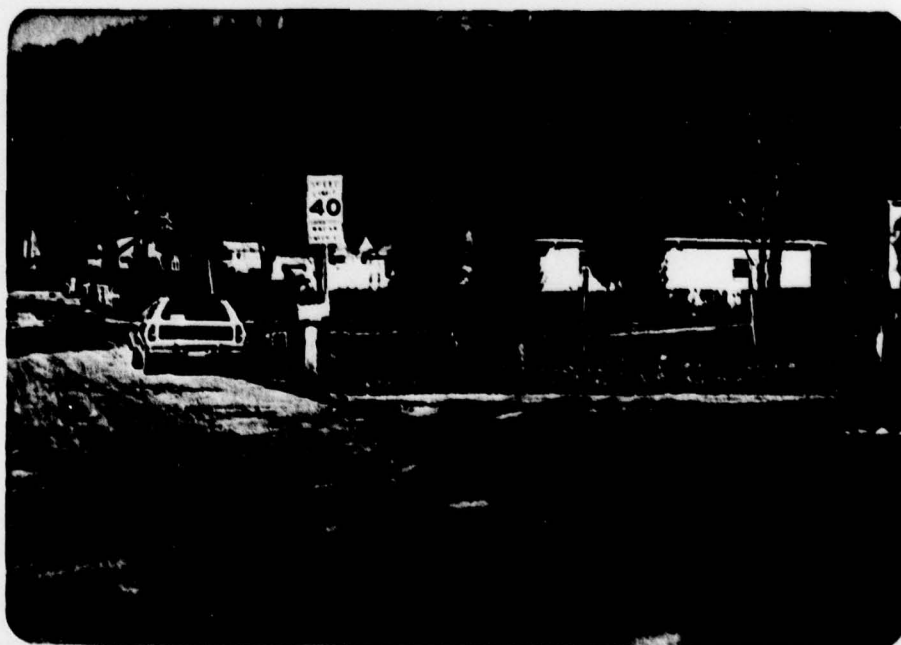
Photograph No. 6

**Community of Hanlin Station approximately
2.5 miles downstream.**
